भारत सरकार / GOVERNMENT OF INDIA
पत्तन, पोत परिवहन और जलमार्ग मंत्रालय
MINISTRY OF PORTS, SHIPPING AND WATERWAYS
नौवहन महानिदेशालय, मुंबई
DIRECTORATE GENERAL OF SHIPPING, MUMBAI

DGS Circular No. – 24 of 2024

Subject: Strengthening Onboard Security and Safety Protocols: Lessons from Recent Haldia Port Casualty

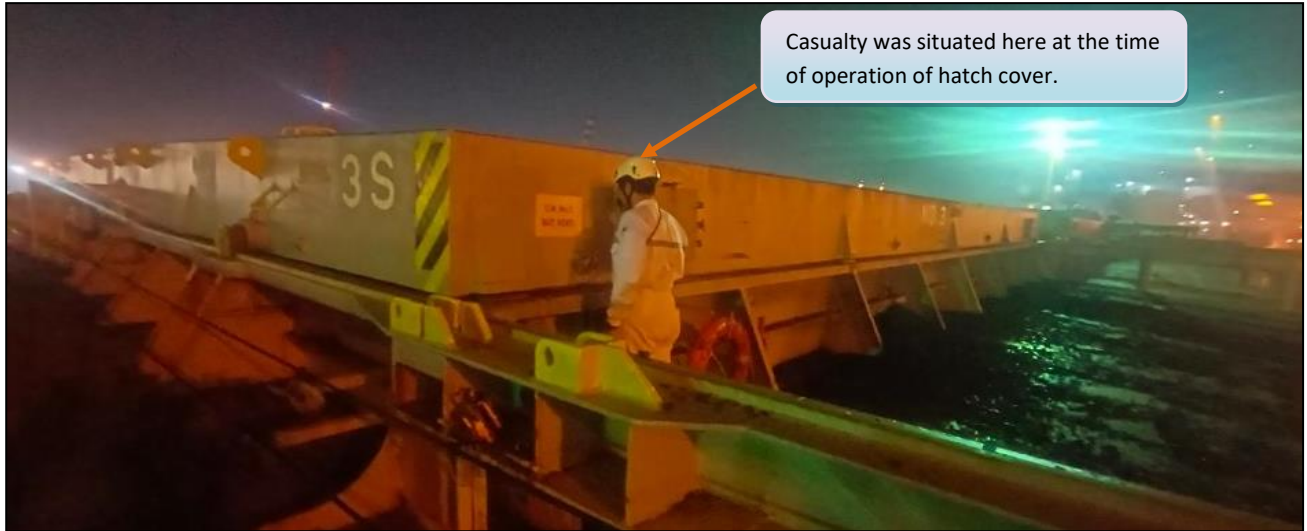
Fig 1: Location of casualty on main deck at the time of incident

On 04.10.2023, one person boarded the vessel, as businessman. Reportedly, the access was denied and he was told to leave the vessel. The location of the gangway is near cargo hold no # 3. The hatch cover extends and reaches close to the boarding area of the gangway, in an open hatch condition.

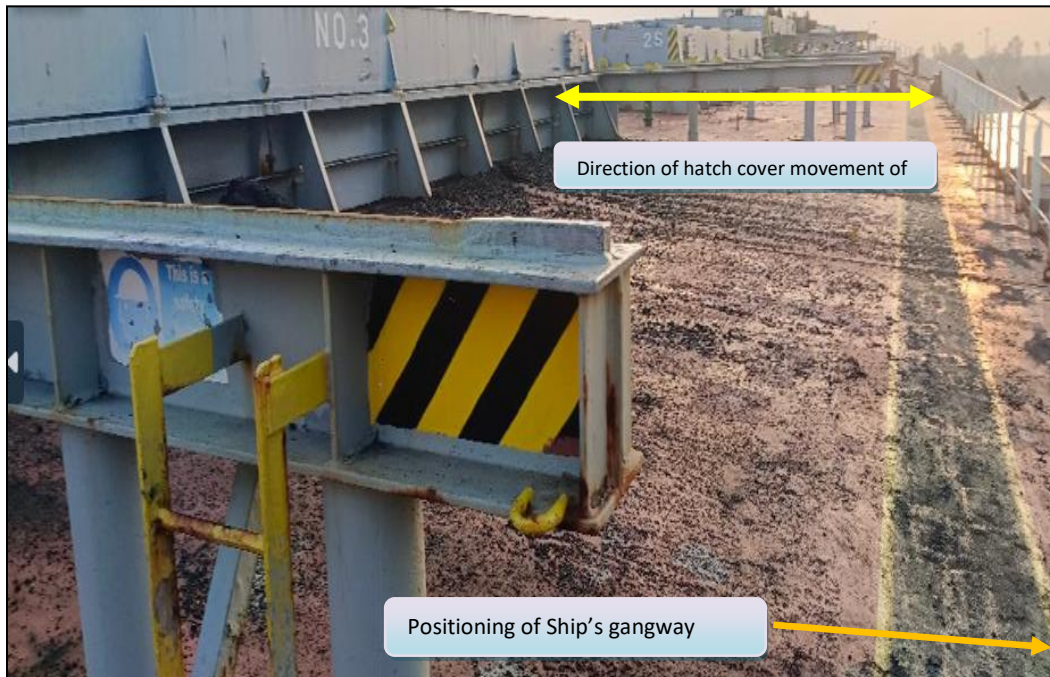
As the person started going down the gangway, it started raining. The gangway watch keeper, and one duty hand went to close the hatch covers of hold no.3 and 5. Meanwhile the deceased person reportedly returned onboard and took shelter from rain underneath the hatch cover of cargo hold no.3. Starboard side, near the gangway.

Fig 2: Hatch cover operation and positioning of gangway

The casualty occurred while closing the hatch cover of cargo hold no.3. The preliminary investigation has identified the root cause and the causal factors of the incident to be as follows:

1. **Failure in basic seamanship:** The presence of only two duty hands on deck to handle cargo and security duties resulted in the gangway being left unattended while they proceeded to close the hatch covers. The general seamanship for giving verbal call or flashing the torch in the area was not carried out.
2. **Failure in compliance with the Safety Management System (SMS) procedure:** The compliance of the hatch cover closing procedure as mentioned in the safety manual was neglected.
3. **Insufficient duty hands:** The manpower at the time was not sufficient, which caused the security duty hand to leave the gangway unattended.
4. **Insufficient illumination at the location:** It was observed during the dark hours that the illumination under the hatch covers was insufficient. The area was lit poorly by the forward

mast aft facing flood light, which was probably obstructed by the rain at the time of the incident.

1. The gangway should be always manned. To reduce the need for constant monitoring, the gangway can be lifted from the jetty during hours of darkness.
2. To ensure safety, security, and operational efficiency, there must always be an adequate number of personnel on deck.
3. Basic seamanship practices, along with safety procedures outlined in the SMS manual, must be strictly always adhered to.
4. Ensure proper illumination of the area between the hatches and underneath the hatch covers.
5. The port should prohibit entry to unauthorized persons during odd hours.
6. The vessels shall ensure that all enclosed and restricted spaces are not accessed unless duly authorized by the vessel personnel. Accesses to enclosed spaces are to be authorized and controlled by ships personnel.
7. Seafarers should receive comprehensive education regarding their responsibilities for all security matters.
